Manhole Inspection Summary

Manhole # S09QQ1006MH

Insp Date: **3/14/08 12:33 PM**

Location Address: **5200 MAPLE AVE**

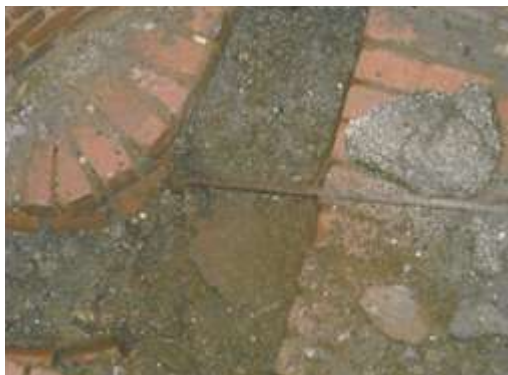
Defect 3

Condition: ☐ Sound ☐ Cracked ☐ Root Intrusion ☐ Deteriorated ☐ Leaks ☒ **Debris**

DEBRIS IN CHANNEL

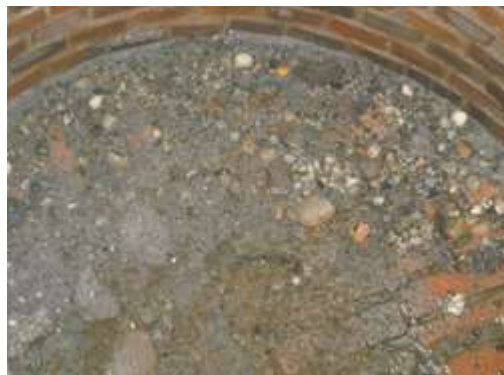
Defect 2

Condition: ☐ Sound ☐ Cracked ☐ Root Intrusion ☐ Deteriorated ☐ Leaks ☒ **Debris**

DEBRIS ON BENCH

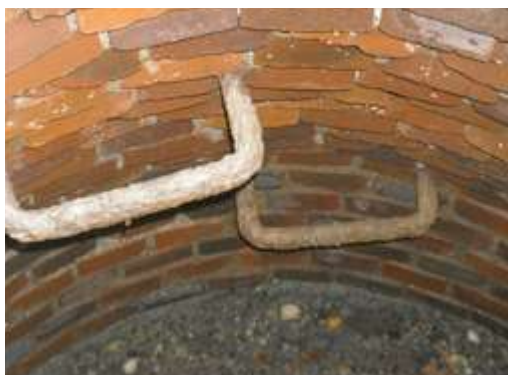
Defect 5

Steps Count: **2** Missing: **0** ☒ **Corroded**

CORRODED STEPS

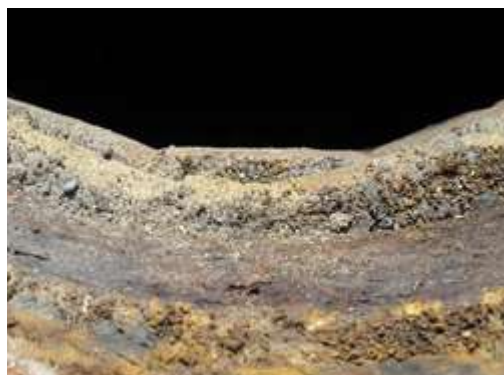
Defect 1

Frame Offset: **1** (in.) Condition: ☒ Sound ☐ Cracked ☐ Leaks

FRAME OFFSET

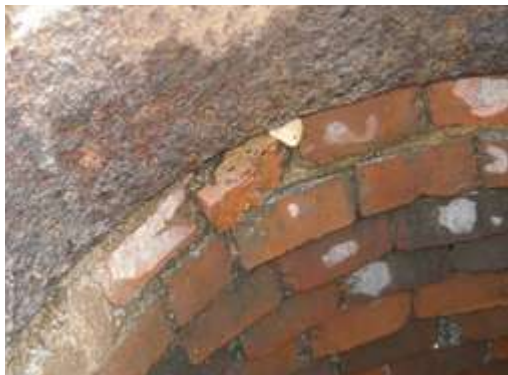
Defect 4

Condition: ☐ Sound ☐ Cracked ☐ Root Intrusion ☐ Loose Brick ☒ **Deteriorated**

DETERIORATED CORBEL

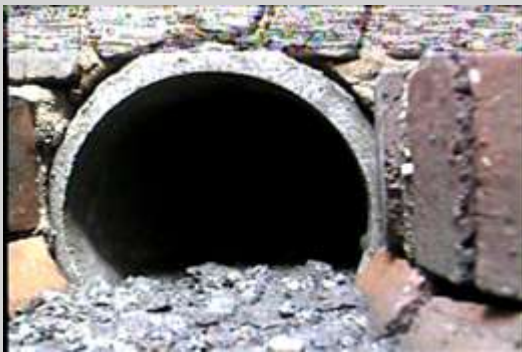
12 O'Clock Outflow

Deposits: ☐ None ☒ **Mud** ☒ **Gravy** ☒ **Debris** ☐ Grease

Silt Depth: **4** (in.) Deposits Extent: **Heavy**

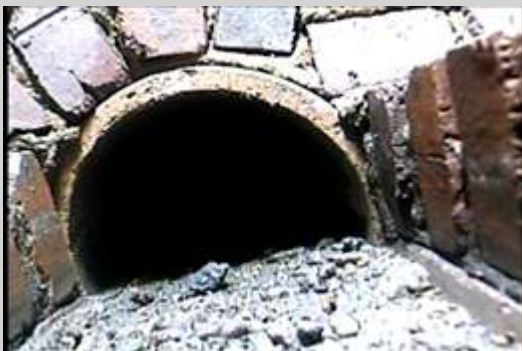
3 O'Clock Inflow

Deposits: ☐ None ☒ **Mud** ☒ **Gravy** ☒ **Debris** ☐ Grease

Silt Depth: **1** (in.) Deposits Extent: **Light**
